DRAFT TREE REPORT

8899 Beverly Project in the City of West Hollywood

June 2013

Tree Report
for
8899 Beverly Project

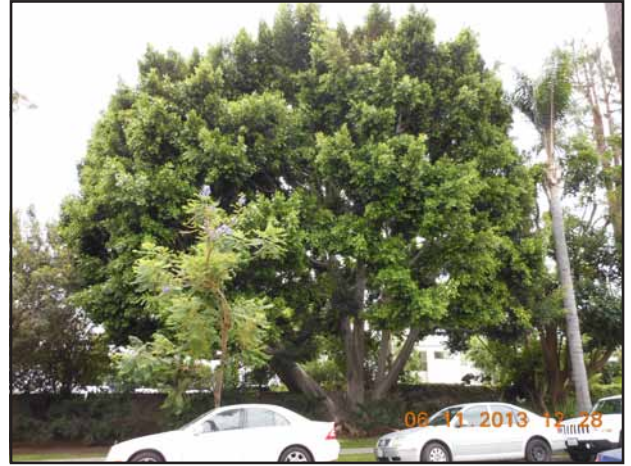
Tree 33

Pursuant to the preliminary designs for the proposed project, the all of the existing trees, with the exception of Tree #33, would be removed as part of the site redevelopment.
