# 4 PRESERVATION BRIEFS

## Roofing for Historic Buildings

Sarah M. Sweetser

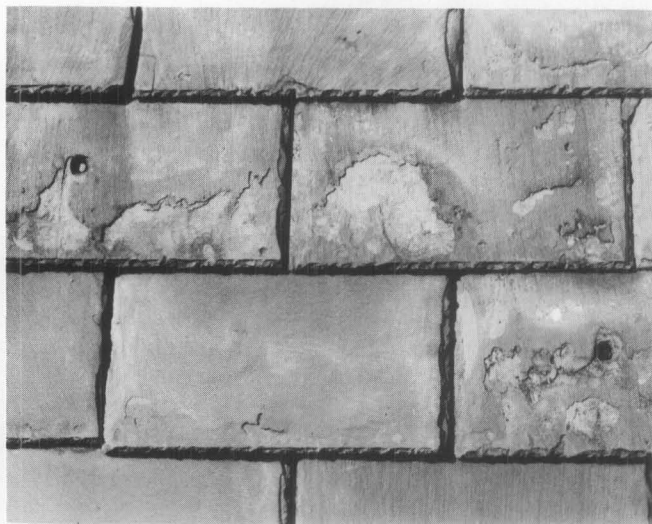
*This detail shows slate delamination caused by a combination of weathering and pollution. In addition, the slates have eroded around the repair nails, incorrectly placed in the exposed surface of the slates. (Lower Pontalba Building, New Orleans, photo courtesy of Building Conservation Technology, Inc.)*

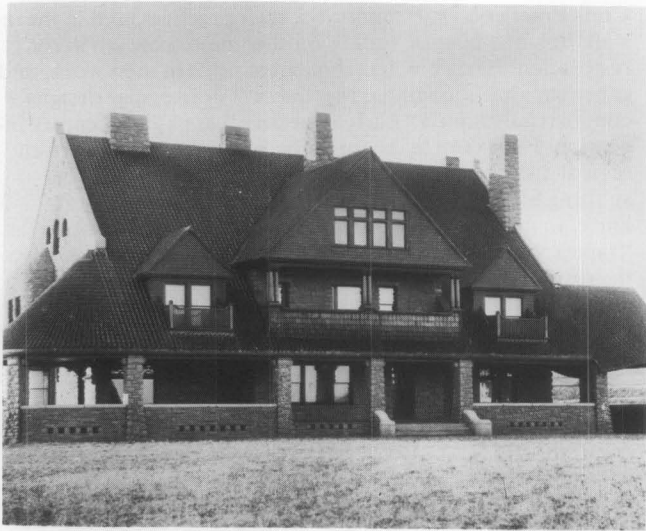
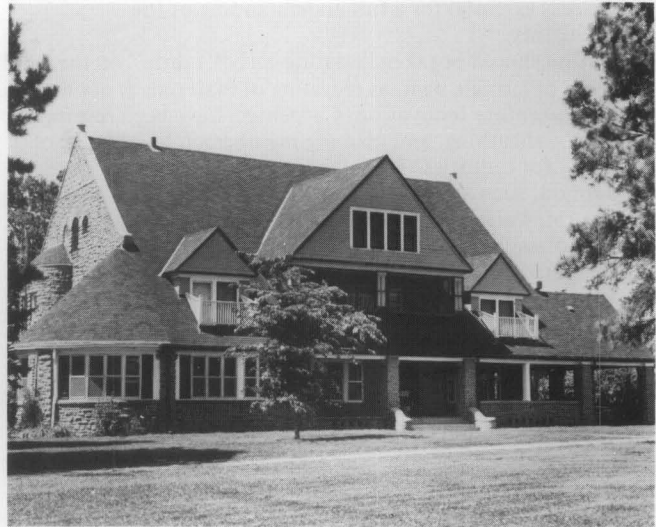
*These two views of the same house demonstrate how the use of a substitute material can drastically affect the overall character of a structure. The textural interest of the original tile roof was lost with the use of asphalt shingles. Recent preservation efforts are replacing the tile roof. (Frank House, Kearney, Nebraska, photo courtesy of the Nebraska State Historical Society, Lincoln, Nebraska)*

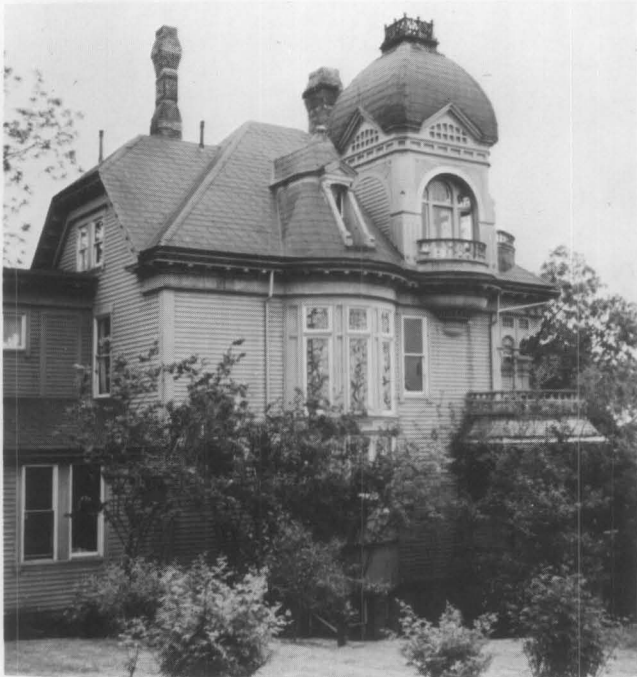
*Special problems inherent in the design of an elaborate historic roof can be controlled through the use of good materials and regular maintenance. The shape and detailing are essential elements of the building's historic character, and should not be modified, despite the use of alternative surface materials. (Gamwell House, Bellingham, Washington)*

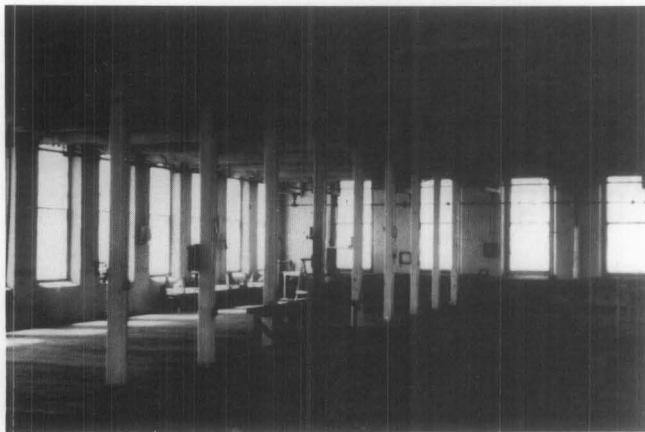
**Permissible Abrasive Cleaning.** In accordance with the Secretary of the Interior's Guidelines for Rehabilitation Projects, it may be acceptable to use abrasive techniques to clean an industrial interior space such as that illustrated here, because the masonry surfaces do not have significant design, detailing, tooling or finish, and the wooden architectural features are not finished, molded, beaded or worked by hand.
