16 PRESERVATION BRIEFS

The Use of Substitute Materials on Historic Building Exteriors

Sharon C. Park, AIA

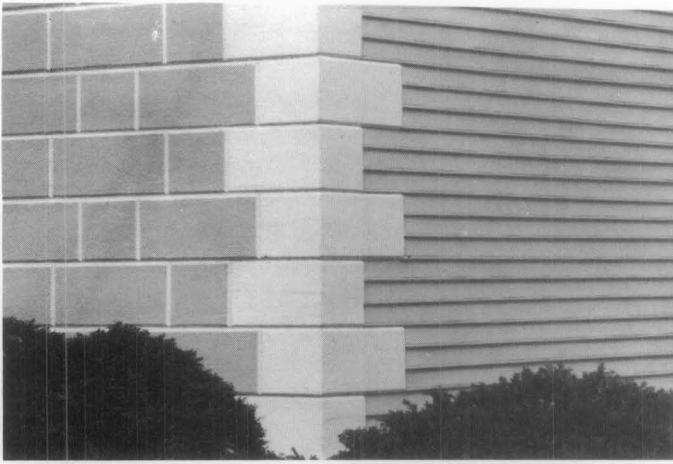
Illus. 1. An early 18th-century technique for imitating carved or quarried stone was the use of sand-impregnated paint applied to wood. The facade stones and quoins are of wood. The Lindens (1754), Washington, D.C. Photo: Sharon C. Park, AIA.

The tradition of using cheaper and more common materials in imitation of more expensive and less available materials is a long one. George Washington, for example, used wood painted with sand-impregnated paint at Mount Vernon to imitate cut ashlar stone. This technique along with scoring stucco into block patterns was fairly common in colonial America to imitate stone (see illus. 1, 2).

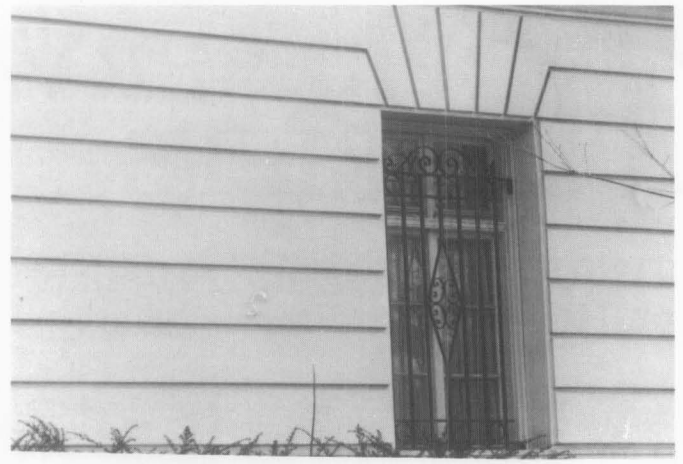
Illus. 2. Stucco has for many centuries represented a number of building materials. Seen here is the ground floor of a Beaux Arts mansion, circa 1900, which represents a finely laid stone foundation wall executed in scored stucco. Photo: Sharon C. Park, AIA.

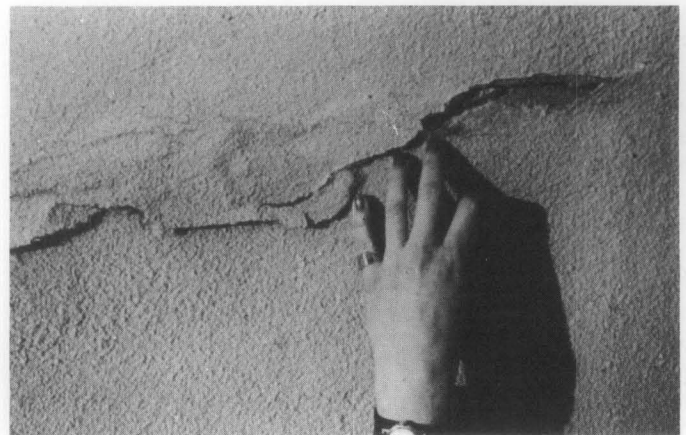
Illus. 6. Substitute materials should never be considered as a cosmetic cover-up for they can cause great physical damage and can alter the appearance of historic buildings. For example, a fiberglass coating was used at Ranchos de Taos, NM, in place of the historic adobe coating which had deteriorated. The waterproof coating sealed moisture in the walls and caused the spalling shown. It was subsequently removed and the walls were properly repaired with adobe. Photo: Lee H. Nelson, FAIA.

Because the overzealous use of substitute materials can greatly impair the historic character of a historic structure, all preservation options should be explored thoroughly before substitute materials are used. It is important to remember that the purpose of repairing damaged features and of replacing lost and irreparably damaged ones is both to match visually what was there and to cause no further deterioration. For these reasons it is not appropriate to cover up historic materials with synthetic materials that will alter the appearance, proportions and details of a historic building and that will conceal future deterioration (see illus. 6).

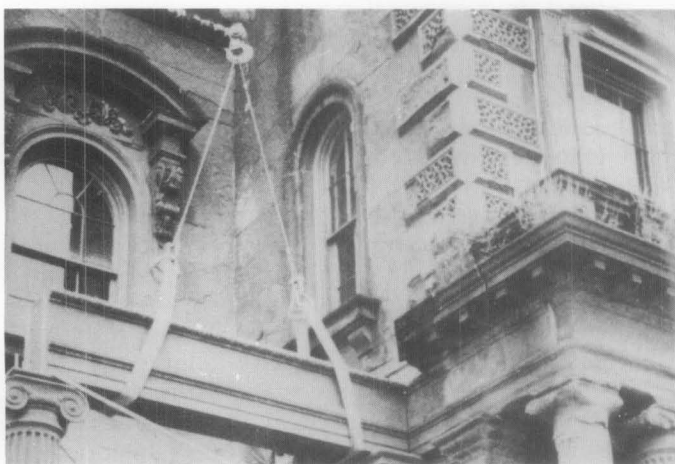
Illus. 9. Simple solutions should not be overlooked when materials are no longer available. In the case of the Morse-Libby Mansion (1859), Portland, ME, the deteriorated brownstone porch beam was replaced with a carved wooden beam painted with sand impregnated paint. Photo: Stephen Sewall.

as a replacement section, achieved using readily available traditional materials, conventional tools and work skills. (see illus. 9). Simple solutions should not be overlooked.

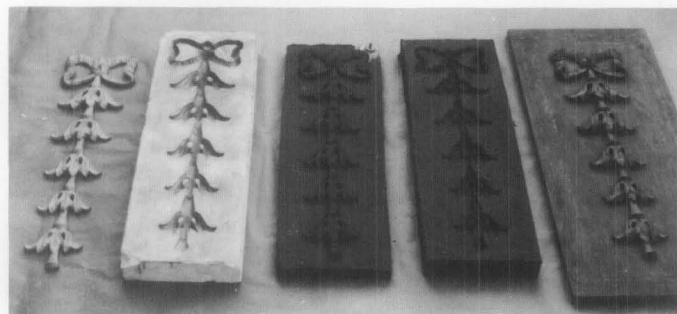
Illus. 10. The use of substitute materials is not necessarily cheaper or easier than using the original materials. The complex process of fabricating the polyester bronze reproduction pieces of the gilded wood molding for the clockcase at Independence Hall required talented artisans and substantial mold-making time. From left to right is the final molded polyester bronze detail; the plaster casting mold; the positive and negative interim neoprene rubber molds; and the expertly carved wooden master. Photo: Courtesy of Independence National Historical Park.

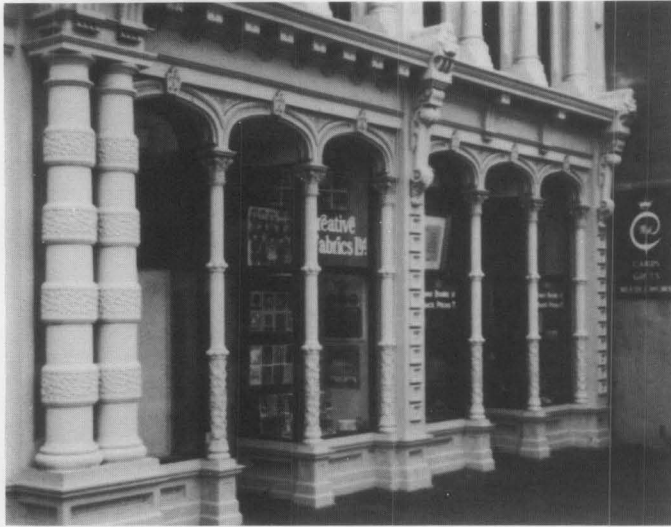
Illus. 11. The unavailability of historic craft techniques is another reason to consider substitute materials. The original first floor cast iron front of the Grand Opera House, Wilmington, DE, was missing; the expeditious reproduction in cast aluminum was possible because artisans working in this medium were available. Photo: John G. Waite.

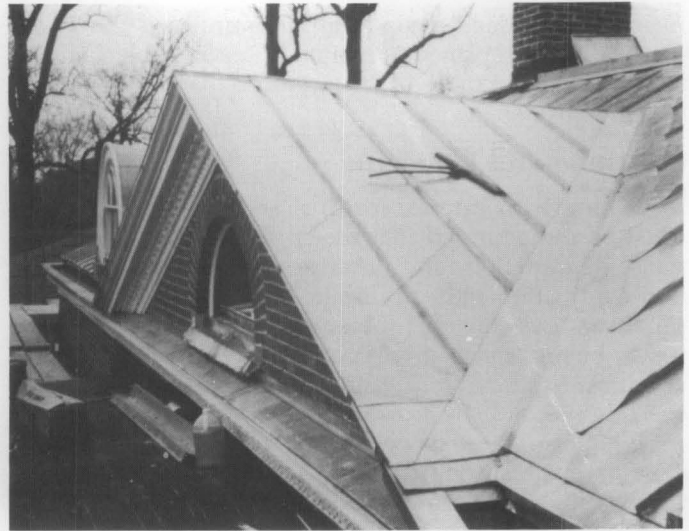
Illus. 12. Substitute materials may be considered when the original materials have not performed well. For example, early sheet metals used for roofing, such as tinplate, were reasonably durable, but the modern equivalent, terne-coated steel, is subject to corrosion once the thin tin plating is damaged. Terne-coated stainless steel or lead-coated copper (shown here) are now used as substitutes. Photo: John G. Waite.

3. Poor original building materials. Some historic building materials were of inherently poor quality or their modern counterparts are inferior. In addition, some materials were naturally incompatible with other materials on the building, causing staining or galvanic corrosion. Examples of poor quality materials were the very soft sandstones which eroded quickly. An example of poor quality modern replacement material is the tin coated steel roofing which is much less durable than the historic tin or terne iron which is no longer available. In some cases, more durable natural stones or precast concrete might be available as substitutes for the soft stones and modern terne-coated stainless steel or lead-coated copper might produce a more durable yet visually compatible replacement roofing (see illus. 12).

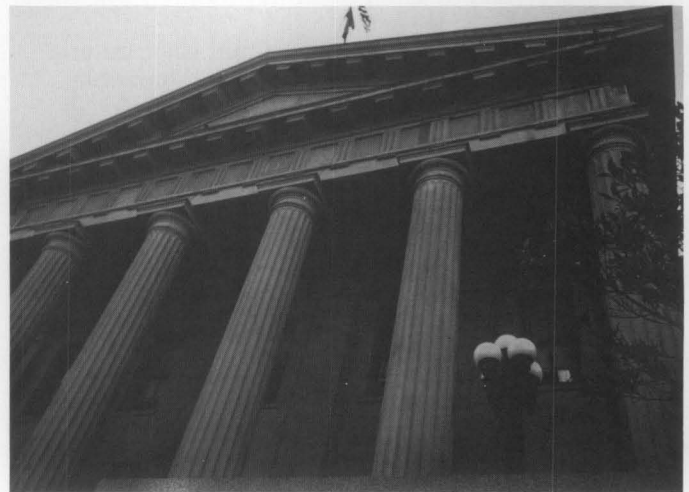
Illus. 13. Code-related changes are of concern in historic preservation projects because the integrity of the historic resource may be irretrievably affected. In the case of the Old San Francisco Mint, the fiberglass cornice was used to bring the building into seismic conformance. The original cornice was deteriorated, and the replacement (1982) was limited to the projecting pediment. The historic stone fascia was retained as were the stone columns. The limited replacement of deteriorated material did not jeopardize the integrity of the building. Photo: Walter M. Sontheimer.

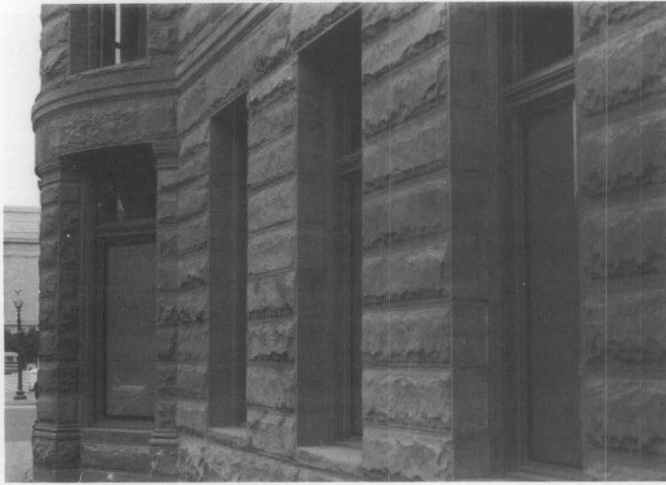
Illus. 16. The good quality substitute materials shown here do match the historic sandstone in color, texture, tooling and surface details. Dry-tamp cast stone was used to match the red sandstone that was no longer available. The reconstructed first floor incorporated both historic and substitute materials. Sufficient molds were made to avoid the problem of detecting the substitutes by their uniformity. Photo: Sharon C. Park, AIA.

Fabricators should supply a sufficient number of samples to permit on-site comparison of color, texture, detailing, and other critical qualities (see illus. 15, 16). In situations where there are subtle variations in color and texture within the original materials, the

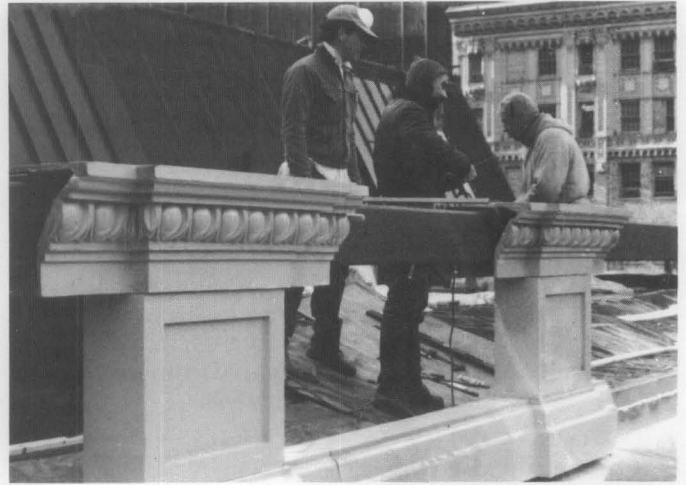
Illus. 18. Substitute materials must be properly installed to allow for expansion, contraction, and structural security. The new balustrade (a polymer concrete modified with glass fibers) at Carnegie Hall, New York City, was installed with steel structural supports to allow window-washing equipment to be suspended securely. In addition, the formulation of this predominantly epoxy material allowed for the natural expansion and contraction within the predesigned joints. Photo: Courtesy of MJM Studios.

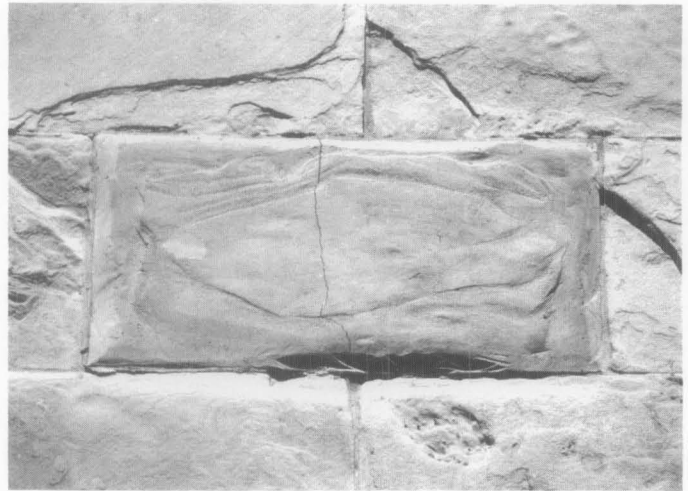
Illus. 19. When the physical properties are not matched, particularly thermal expansion and contraction properties, great damage can occur. In this case, an extremely rigid epoxy replacement unit was installed in a historic masonry wall. Because the epoxy was not modified with fillers, it did not expand or contract systematically with the natural stones in the wall surrounding it. Pressure built up resulting in a vertical crack at the center of the unit, and spalled edges to every historic stone that was adjacent to the rigid unit. Photo: Walter M. Sontheimer.

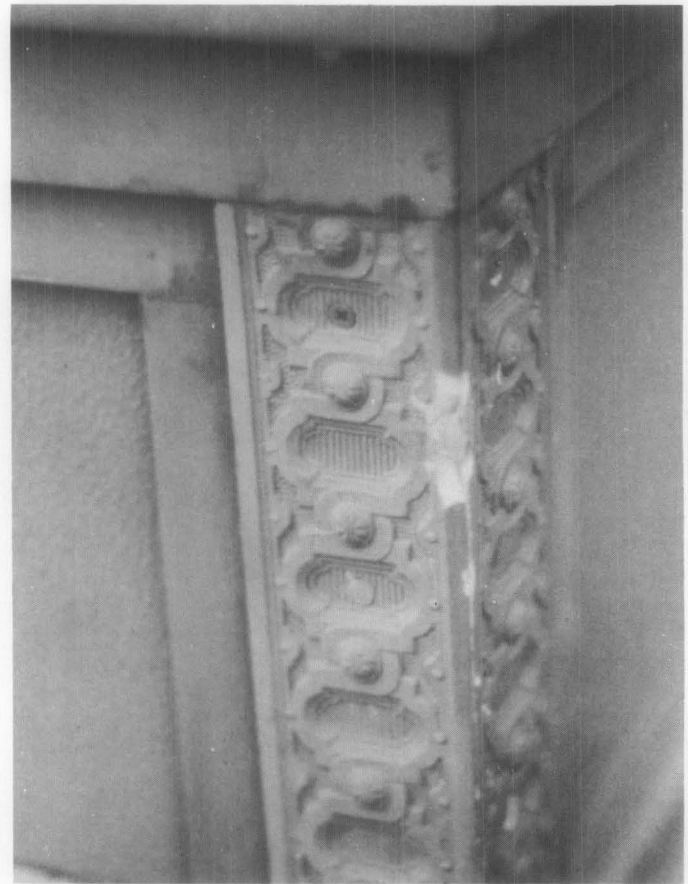
Illus. 20. Long-term performance can be affected by where the substitute material is located. In this case, fiberglass was used as part of a storefront at street level. Due to the brittle nature of the material and the frequency of impact likely to occur at this location, an unsightly chip has resulted. Photo: Sharon C. Park, AIA.

While a substitute material may appear to be acceptable at the time of installation, both its appearance and its performance may deteriorate rapidly. Some materials are so new that industry standards are not available, thus making it difficult to specify quality control in fabrication, or to predict maintenance requirements and long term performance. Where possible, projects involving substitute materials in similar circumstances should be examined. Material specifications outlining stability of color and texture; compressive or tensile strengths if appropriate; the acceptable range of thermal coefficients, and the durability of coatings and finishes should be included in the contract documents. Without these written documents, the owner may be left with little recourse if failure occurs (see illus. 20, 21).

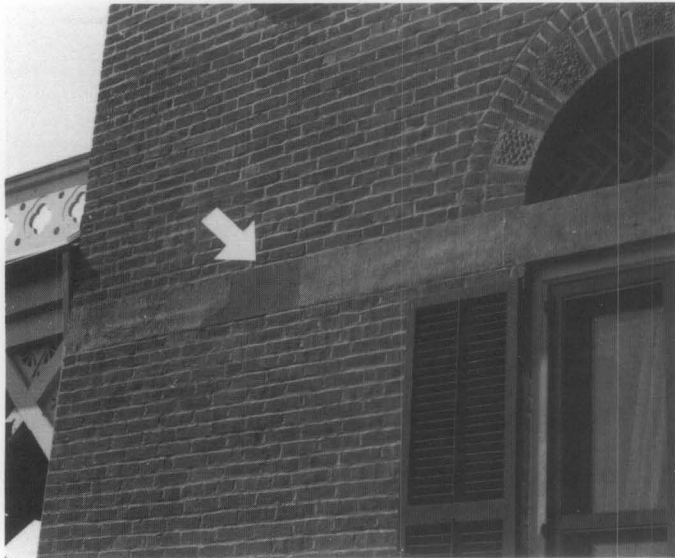
Illus. 21. Change of color over time is one of the greatest problems of synthetic substitute materials used outdoors. Ultra-violet light can cause materials to change color over time; some will lighten and others will darken. In this photograph, the synthetic patching material to the sandstone banding to the left of the window has aged to a darker color. Photos: Sharon C. Park, AIA.

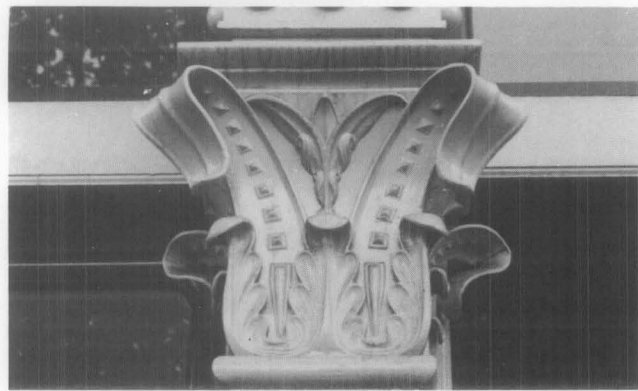
Close-up detail showing the crisp casting in aluminum of this 19th-century replica column and capital for a storefront. Photo: Sharon C. Park, AIA.

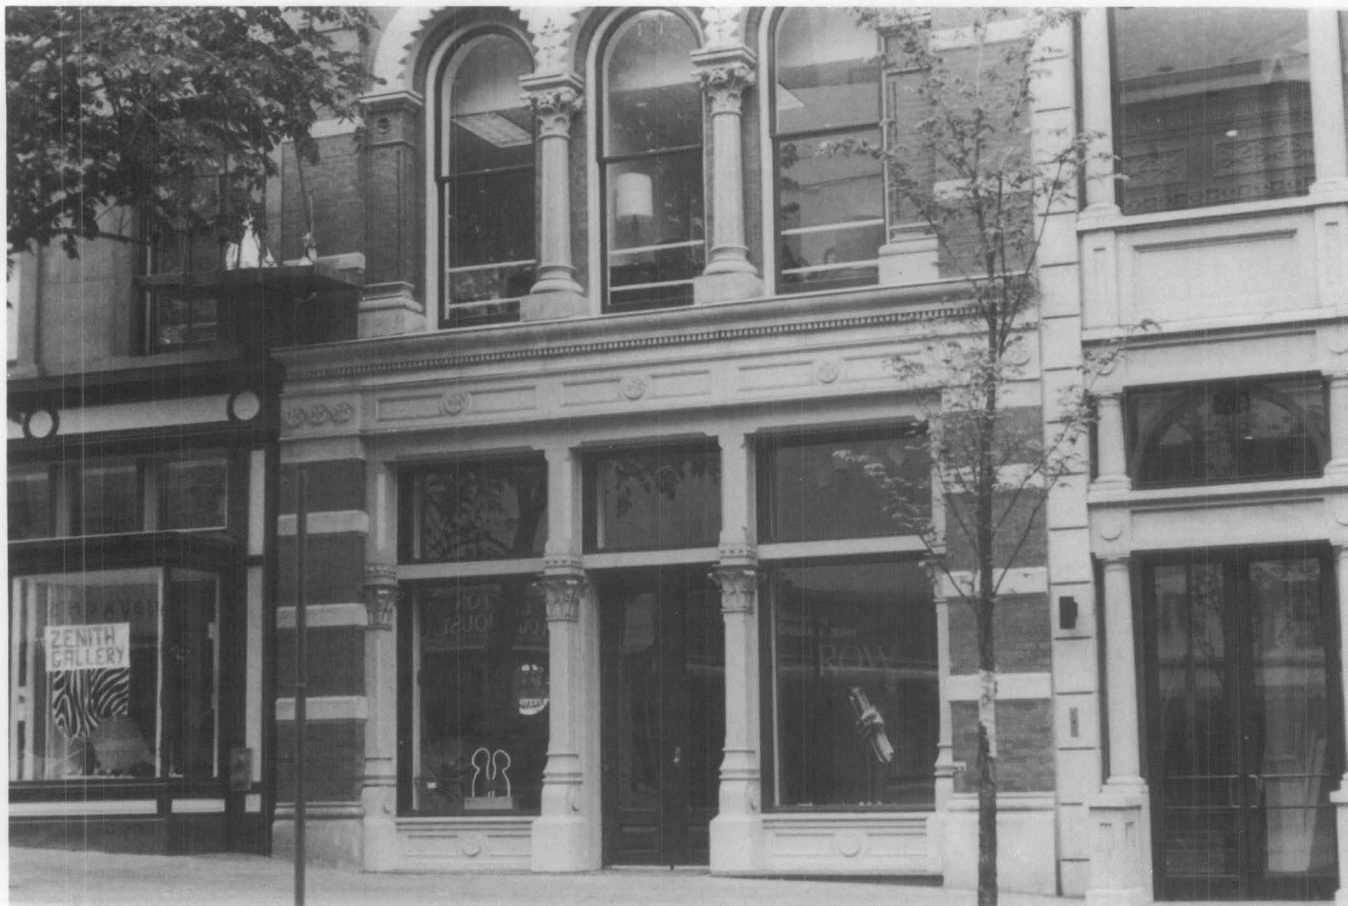
The new cast aluminum storefront replaced the lost 19th-century cast-iron original. Photo: Sharon C. Park, AIA.

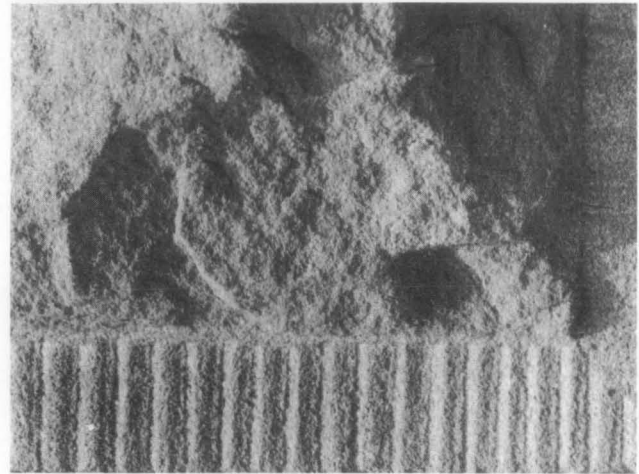
Dry-tamped cast stone can reproduce the sandy texture of some natural stones. Photo: Sharon C. Park, AIA.

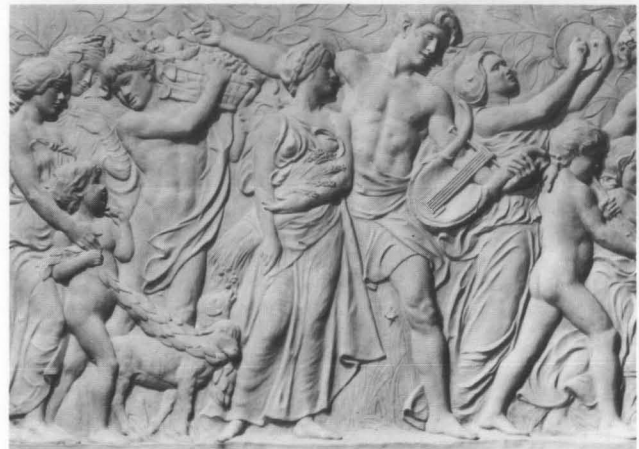
This glass fiber reinforced concrete sculptural wall panel will replace the seriously damaged resin and plaster original. A finely textured surface was achieved by spraying the GFRC mix into molds that were created from the historic panel and resculpted based on historic photographs. Photo: Courtesy of MJM Studios.

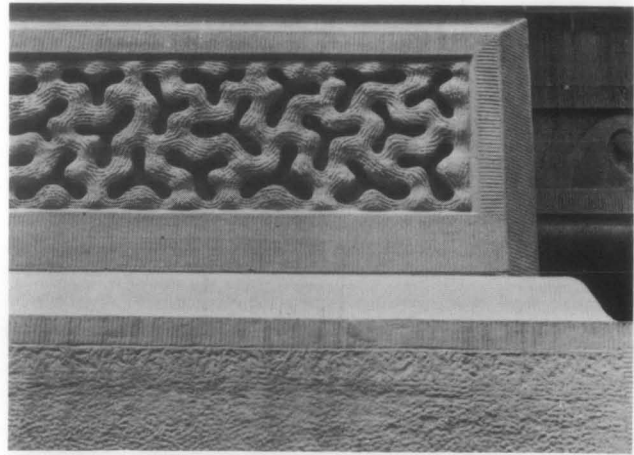
Textured molds can produce a variety of high quality carved, quarried, and tooled surfaces in concrete.

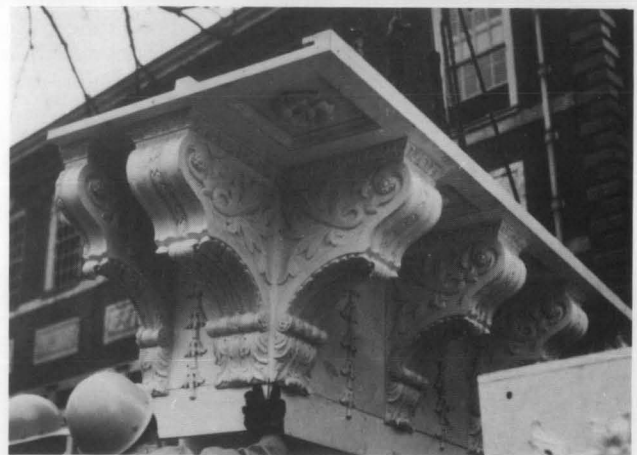
A fiberglass cornice for the reconstruction of an 18th-century wooden clockcase is being lifted in pre-fabricated sections. The level of detail is intricate and of high quality. Photo: Courtesy of Independence National Historical Park.

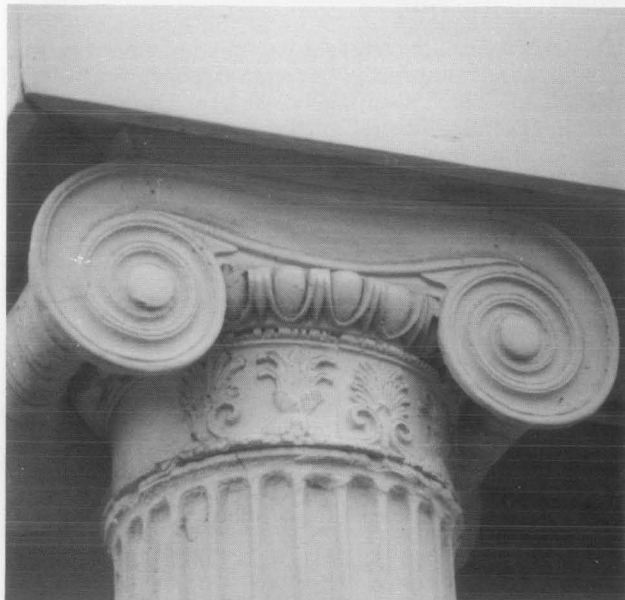
This replica column capital was made using epoxy resins poured into a mold taken from the building. The historic wooden column shaft was repaired during the restoration. Photo: Courtesy Dell Corporation.

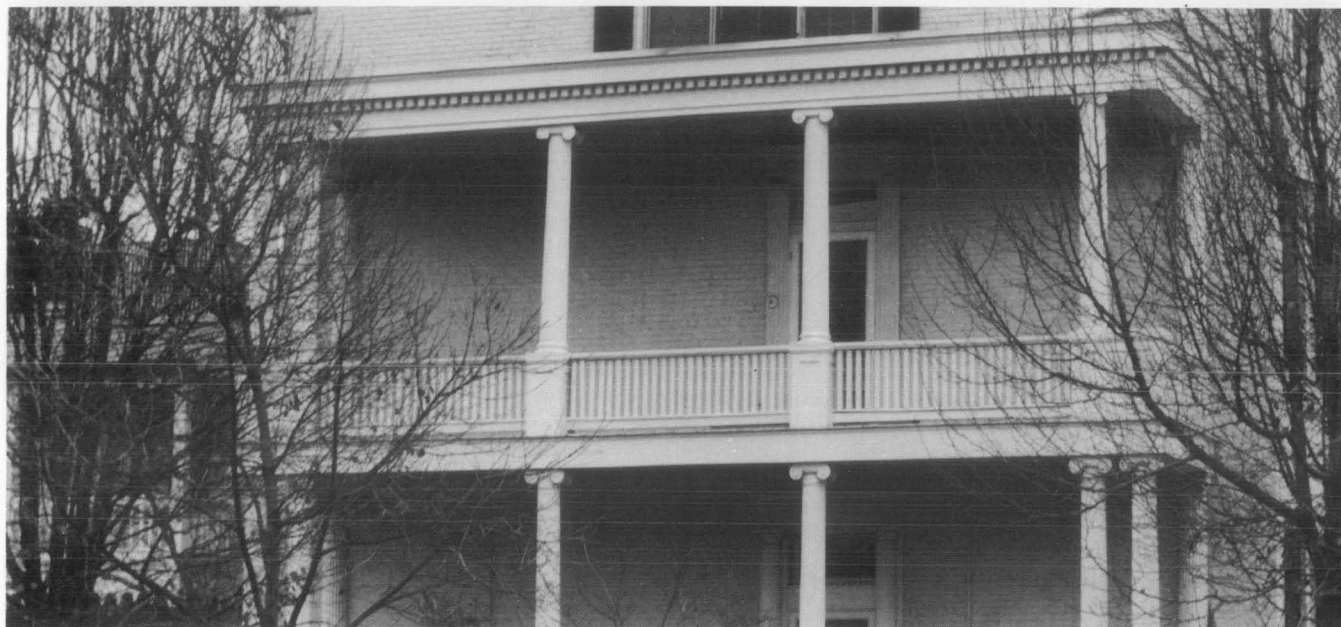
Columns were repaired and a capital was replaced in epoxy on this 19th-century 2-story porch. Photo: Dell Corporation
