45 PRESERVATION BRIEFS

Preserving Historic Wood Porches

Aleca Sullivan and John Leeke

National Park Service
U.S. Department of the Interior
Heritage Preservation Services

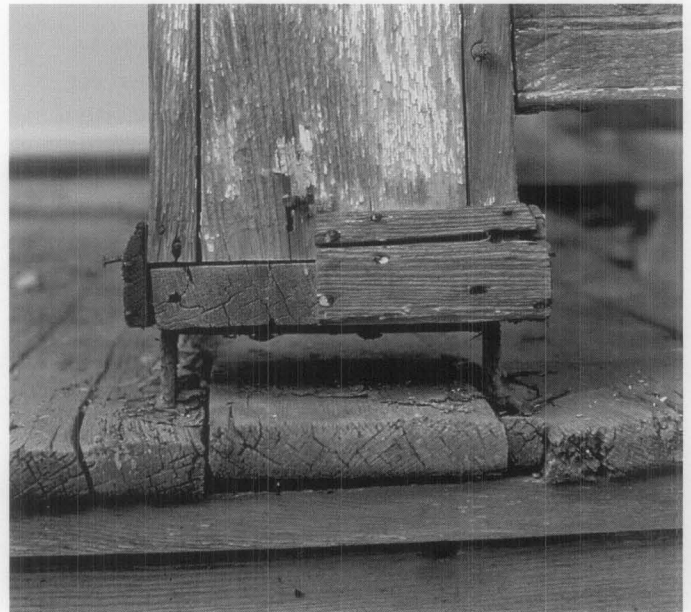
Figure 6. A traditional way to extend the life of porch posts was to place posts on metal feet, thereby providing a separation between the wood post and wood deck. This helped to prevent the wood post from rotting at the base. Early post feet were simple iron bars bent unto a stirrup shape. By the late nineteenth century manufactured cast-iron feet were common, consisting of a pair of disks separated by a short pipe. Post feet are still available today. Courtesy of Old-House Journal/Brian McNeil.

are made of and how they are constructed will aid in understanding how they function and may deteriorate over time (Fig.6). Although the posts on a wood porch are commonly made of wood, they may be of masonry or metal or a combination of materials. Large round columns usually are made of wood staves similar to the way barrels are constructed; smaller diameter columns may be solid. A sag in the deck below or a faltering foundation can impact the supporting role of a column or post above. Wood columns and posts are prone to water seeping into open joints, particularly in the base and the lower end of the shaft. It is not uncommon to find that older columns have had patches and replacement bases.

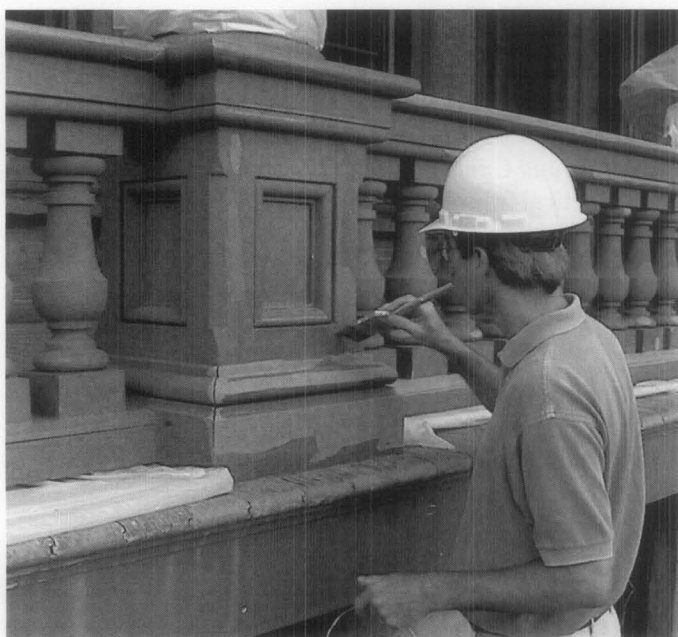
Figure 8. Decay can start when wood is left exposed to the weather or where joints open up. An inexpensive way to extend the life of the existing porch paint without jeopardizing the historic material is spot paint and caulk where needed every year or two. This cost-effective procedure is particularly effective in maintaining wood porches where the exposure to weathering is high. Photo: John Leeke.

Spot painting and resealing of open joints should be undertaken at least every other year (Fig. 8). Heavily used stair treads may require more frequent paint touchup. When peeling paint or bare wood is evident, inspect to ensure it is not signaling deeper problems, such as decay. With sound wood, scrape off the loose paint, sand, prime, and repaint the area. Where lead paint is present, appropriate lead hazard precautions and procedures apply. Only top-quality exterior primers and paints are recommended, selecting for the deck and stairs specially formulated paints. Where wood porch steps are exposed to moisture, grit added to the wet paint during application will help improve safety.

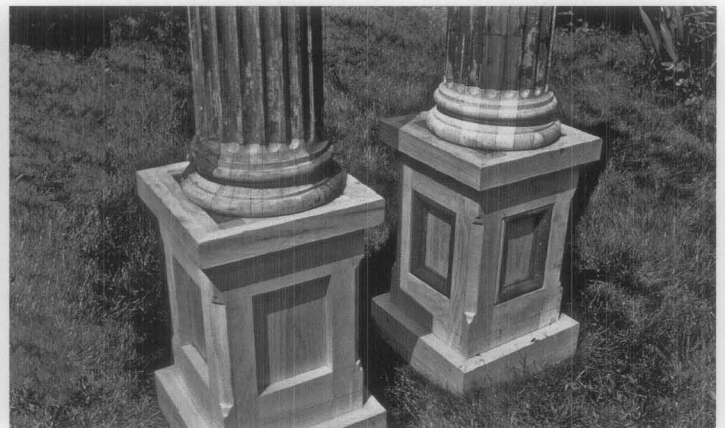
Figure 10. This nineteenth century porch column is made of wood staves, similar to the way a wood barrel is put together. After replacing the torus and making dutchman repairs to the apophyge along the base, the column and pedestal are ready to be reinstalled on the porch. Photos: NPS files.

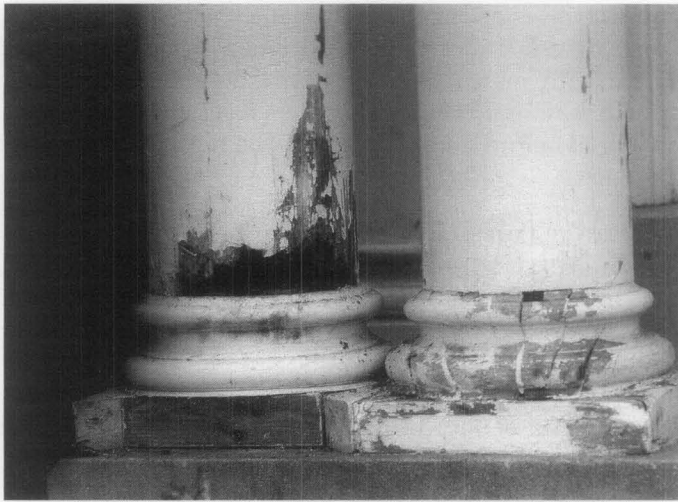
Figure 11. The lower shaft of the porch columns had decayed as water wicked up through the end grain (top). The column shafts were repaired in place by cutting out the deteriorated wood and making repairs using epoxy consolidants and fillers. (bottom). The column bases were replaced. Photos: Paul Marlowe, Marlowe Restorations.

When plinths and bases are deteriorated beyond repair, they can be replaced without replacing the column shaft, which may still be in good condition or require only minor repairs at the bottom. Such replacement will involve temporary shoring for the roof. One-story columns and shafts are often more easily removed during this work, while taller columns are sometimes supported in place. If only a few plinths or bases are deteriorated, it is often economical to have new ones made of wood to match. If numerous plinths and bases are deteriorated, replacing with bases made of rot-resistant materials can make economic sense; however, care must be taken to ensure that all the visual qualities including design, size, shape, color and texture of the historic part are matched (Fig. 11).

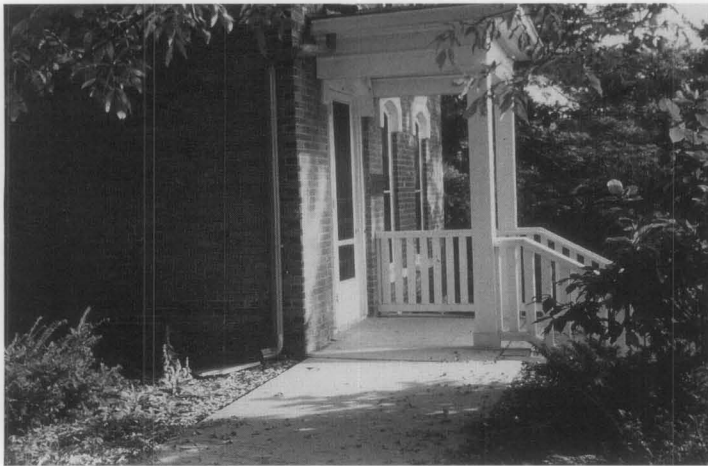
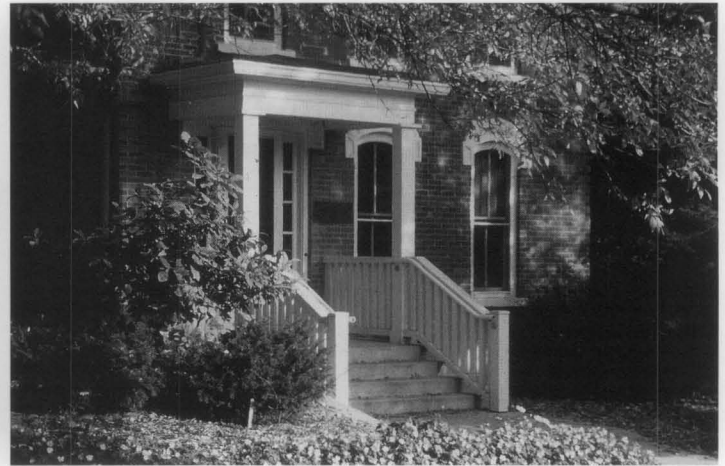
Figure 18. When a porch is used as a wheelchair accessible entrance, it may be possible to retain the historic stairs by adding a ramp parallel to the building. Through plantings and some re-grading, the new ramp built parallel to the building (left) allows retention of the historic stairs and does not impact the historic character of the entrance (right). Photo: Iowa State University Extension.

entrance alternative. It may be possible to retain the historic stairs by adding another entrance to the porch with the construction of a ramp parallel to the building (Fig. 18).

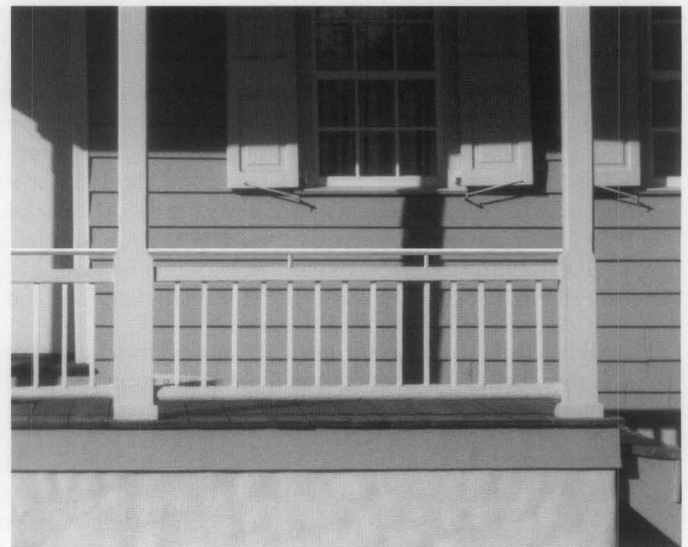
Figure 19. Historic porches generally have railings that measure 28 to 30 inches in height from the floor. When additional height is necessary for safety, a simple rail, added for illustration purposes in this photograph, can usually be installed above the historic railing. Not only does this treatment allow retention of the historic balustrade, but it also has a minimum impact to the appearance of the porch. Photo: Charles Fisher.
